Re: Notice of Violation
Compliance Evaluation Inspection
April 8, 2015
EPA ID No. PAD002326908

INSPECTION REPORT

ARCELORMITTAL PLATE LLC.

April 8, 2015

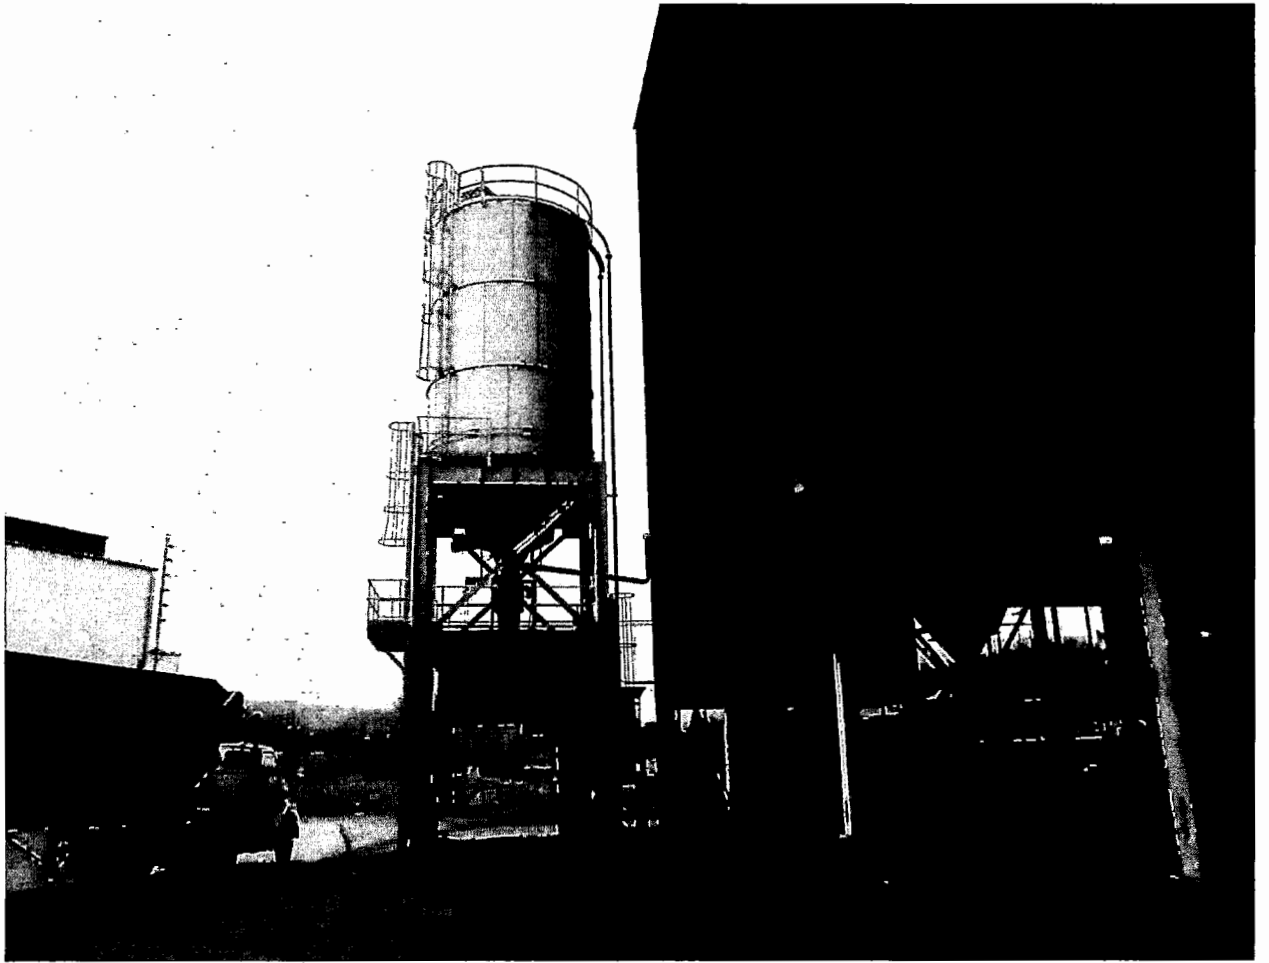
The inspectors started the inspection by going to the melt shop where the electric arc furnace is located. On the way, the inspectors observed the baghouse and loading area for the ambient air ventilation system from the melt shop (Photo #1). There was no truck load at the time of the inspection. The area was clean and well maintained. This baghouse collect about 5% of the total dust at the facility. From this location we observed the large duct coming from the melt shop and furnace (Photo #2).

Photo #1 – Shilo and loading station for dust from melt shop ventilation baghouse on right.

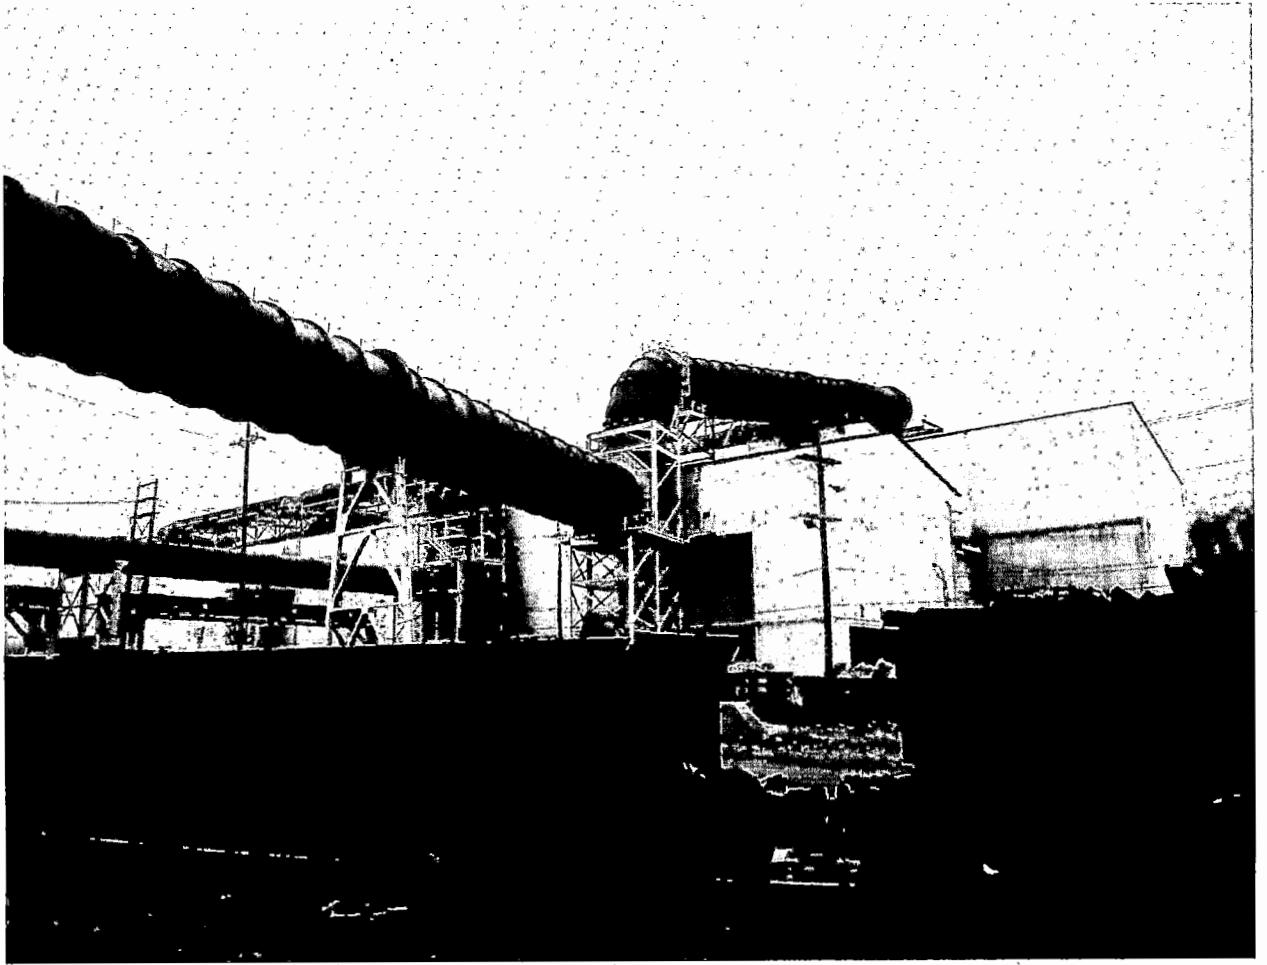
Photo #2 – Flue dusts from melt shop. The large duct in foreground is from the ventilation system and the smaller one to the left carries the EAF dust from the furnace.

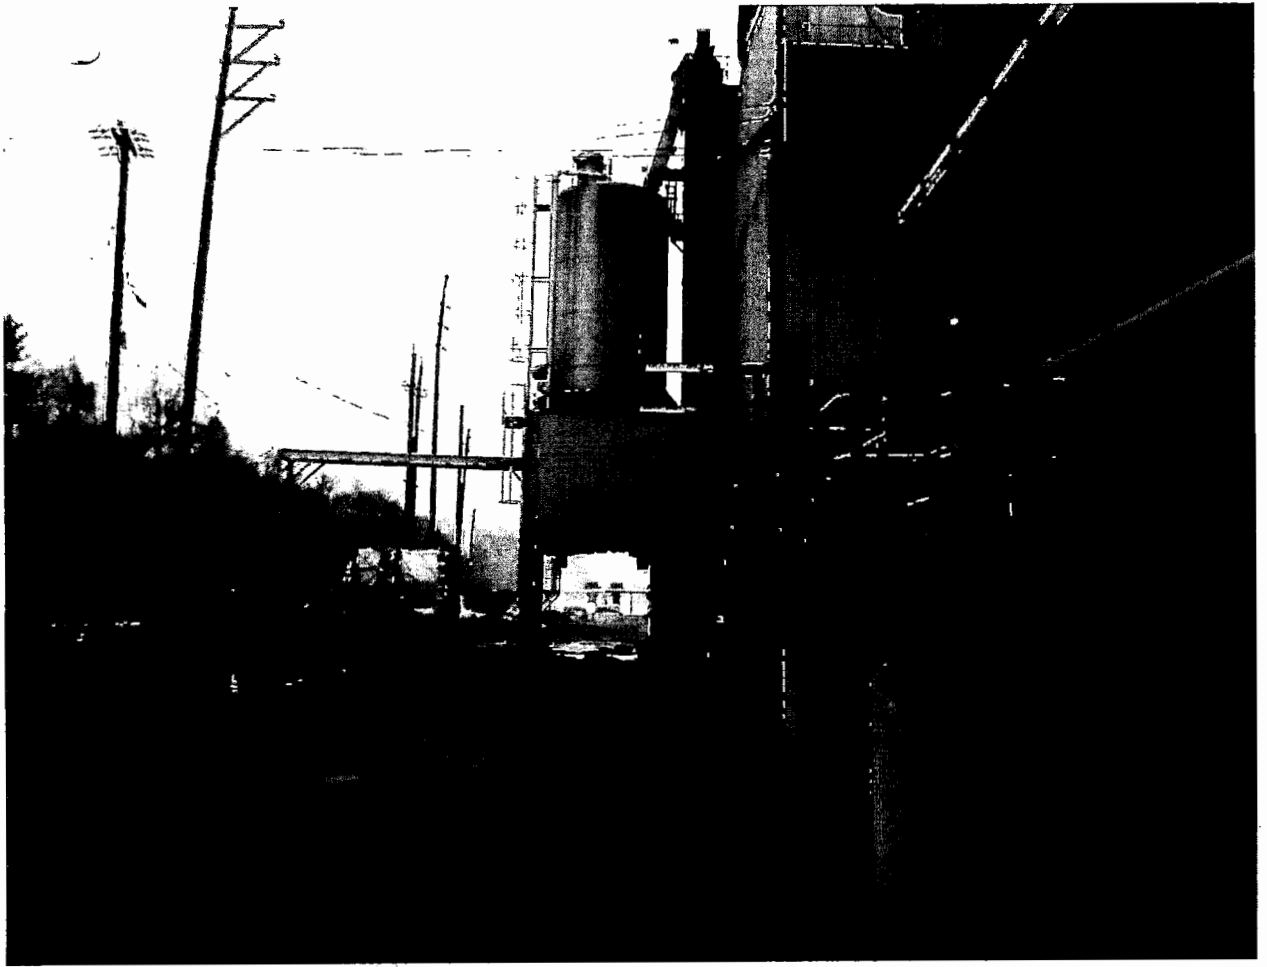
The inside the melt shop there are no wastes generated aside from the emissions that are routed directly to the baghouses across the rail yard so the inspector proceeded outside the area where the EAF dust is loaded (Photo #3). The loading area for this baghouse was also very clean with no fugitive dust visible. There is a vac-truck and a rolloff box that combined to serve as a giant vacuum cleaner for keeping the area clean. The rolloff (Photo #4) is labeled as hazardous waste (K061) and dated 3/18/15. As the inspectors were leaving the area an empty truck was backing in to be loaded with EAF dust (Photo #5).

Photo #3 – Shilo and loading station from EAF dust baghouse.

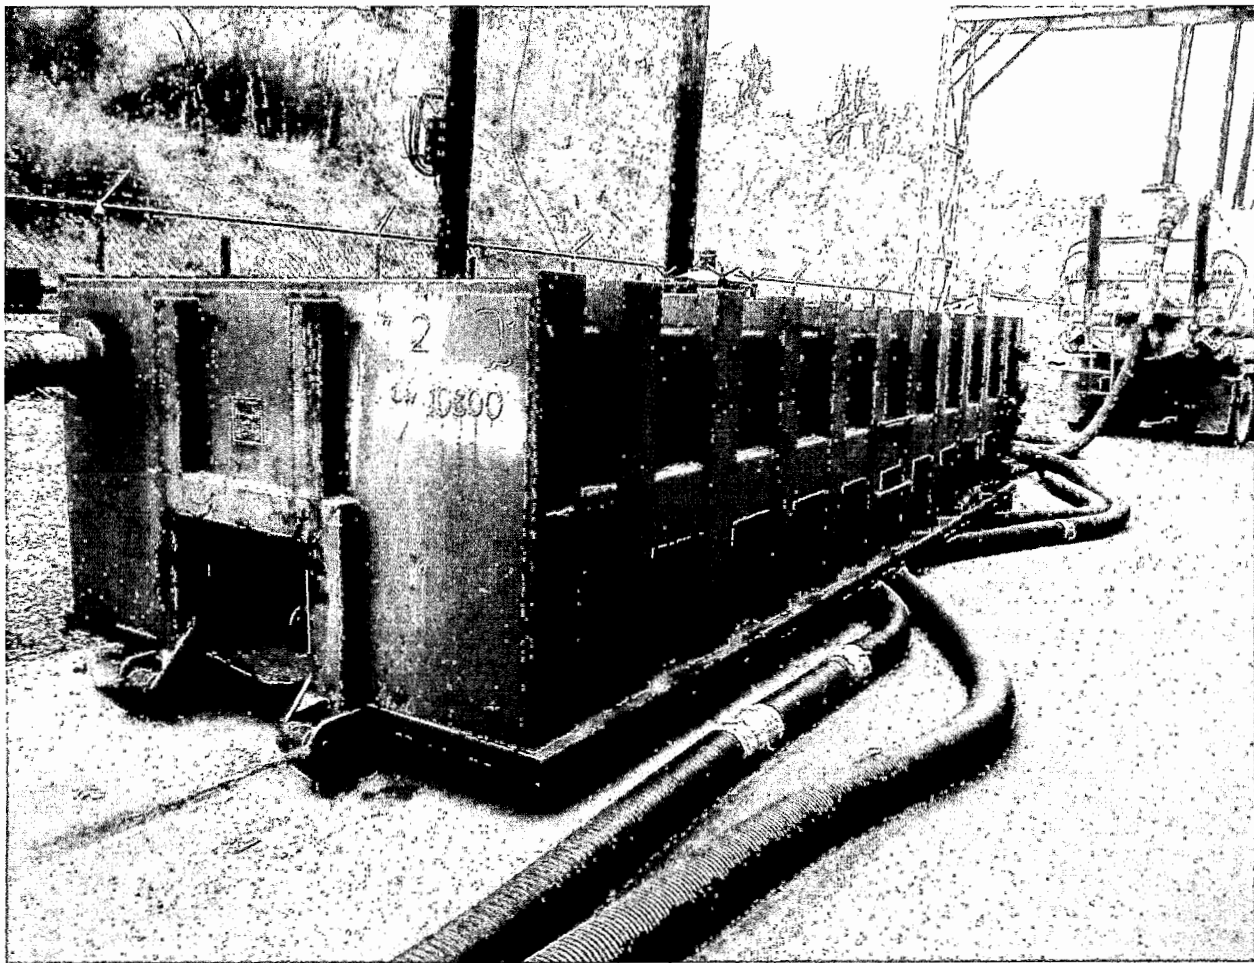
Photo #4 – Vacuum box for storage of fugitive EAF dust from loading operation. Labeled hazardous waste and dated 3/18/15.

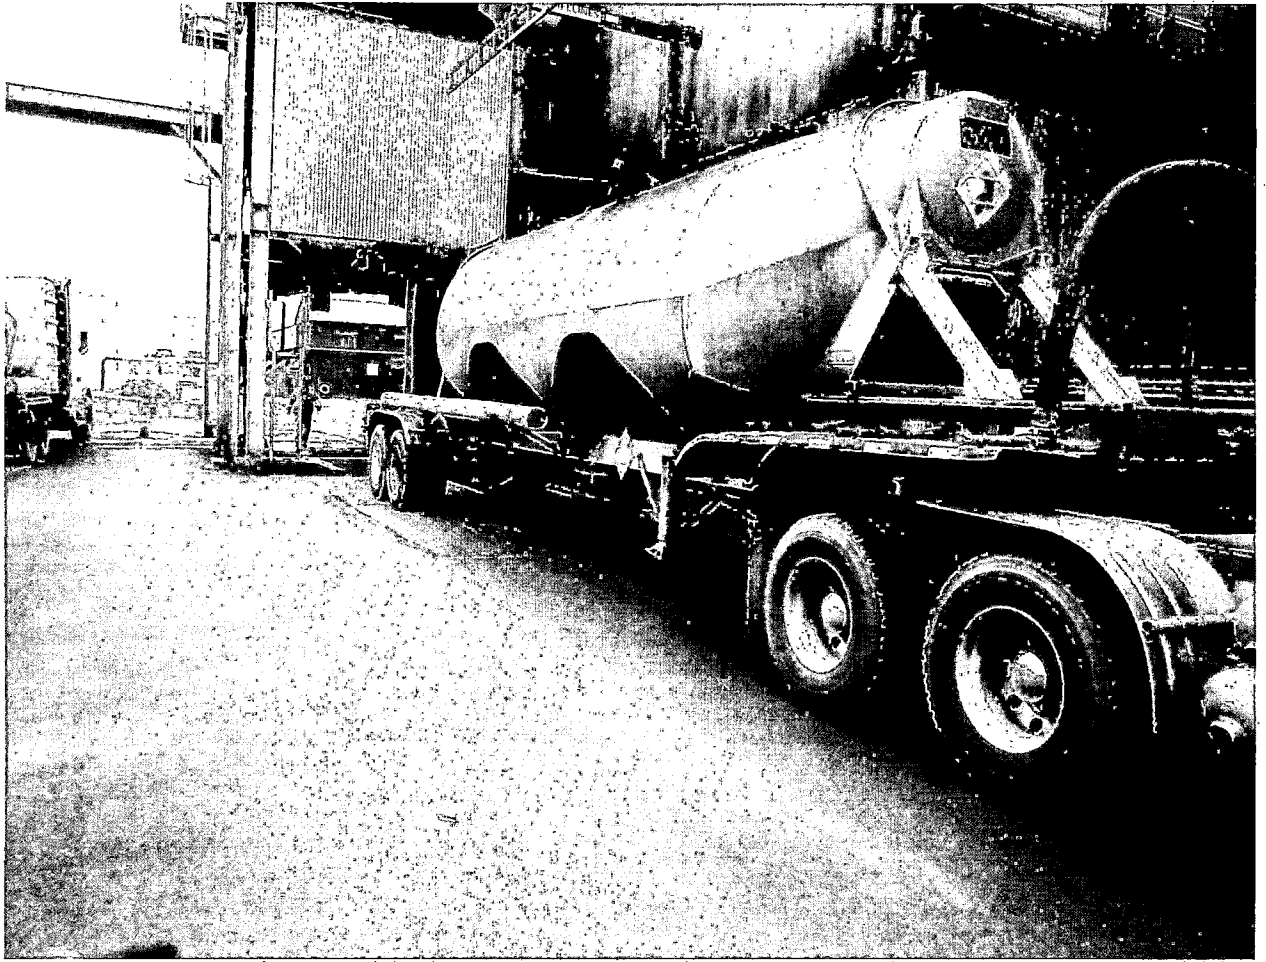
Photo #5 – EAF dust ready for loading into transporter trailer.

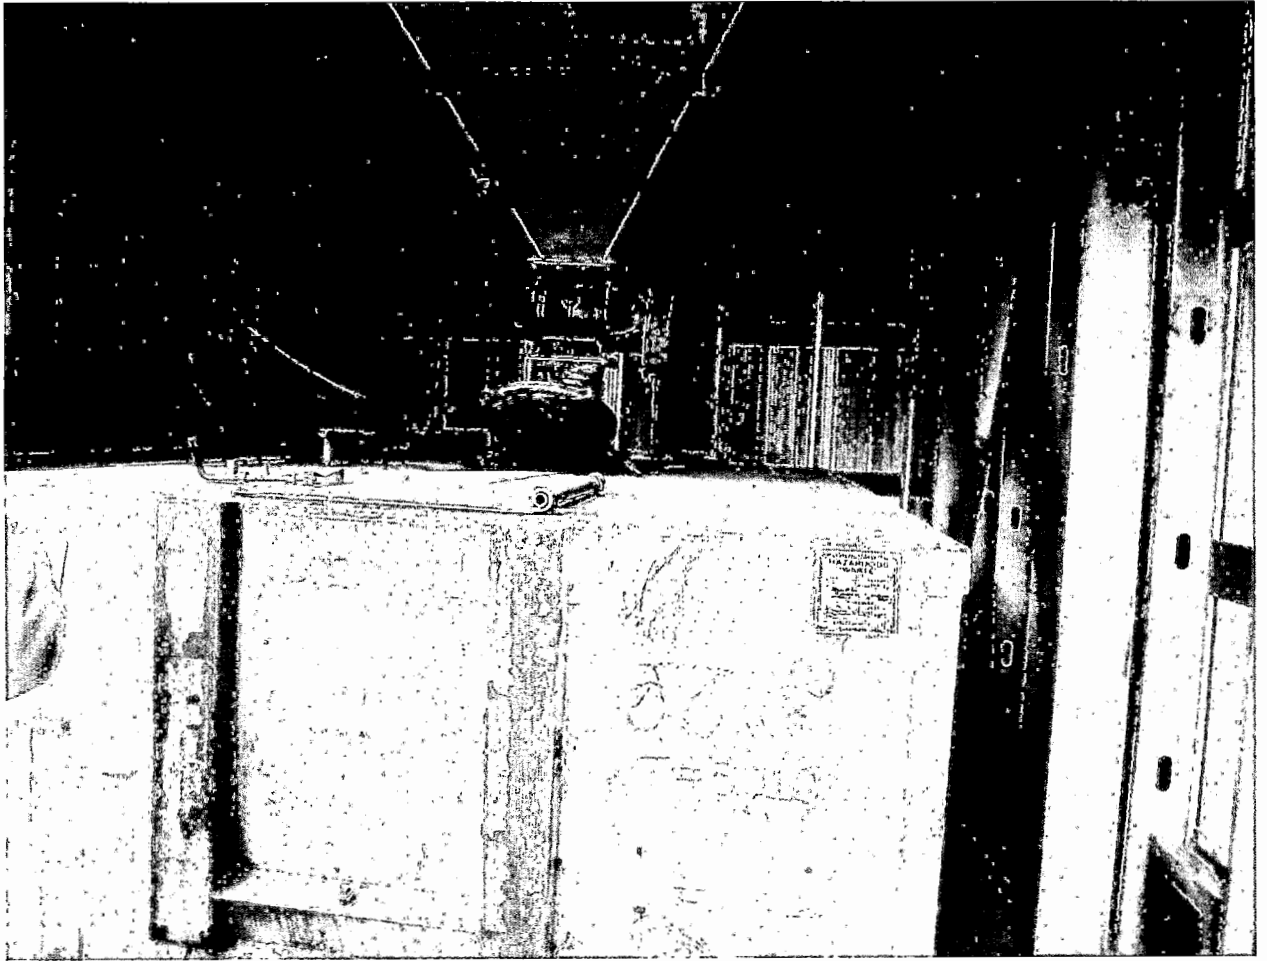
Another baghouse is associated with the alloying conditioning area (Photo #6) where slabs and plates are cut to size. The rolloff box which received waste from the silo was labeled

hazardous waste (D007) and dated 3/19/15. This rolloff is only shipped every 6 weeks.

Photo #6 – Dust collection rolloff box from the Alloy Conditioning Area is labeled hazardous waste (D007) and dated 3/19/15.

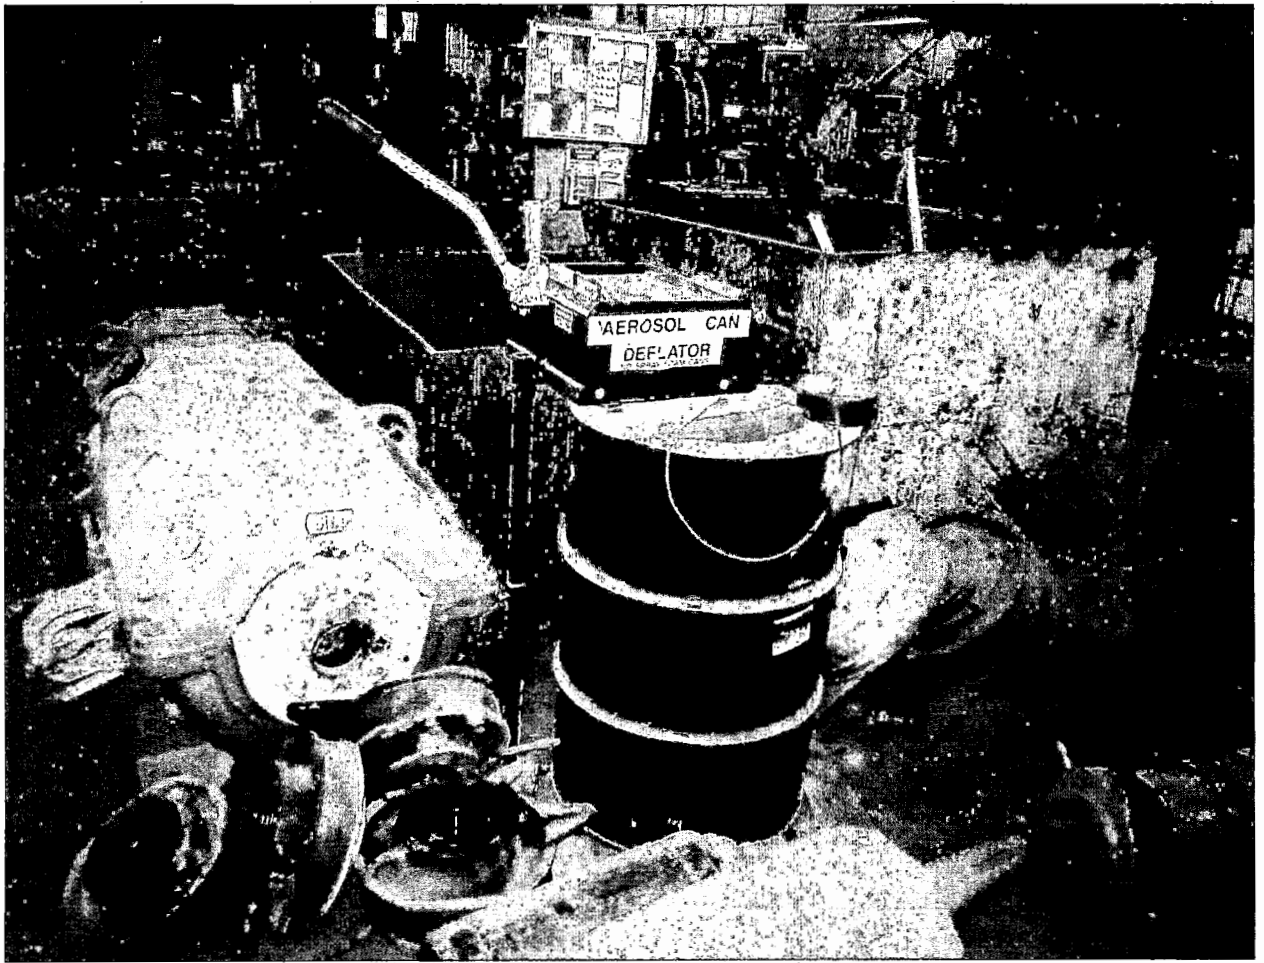
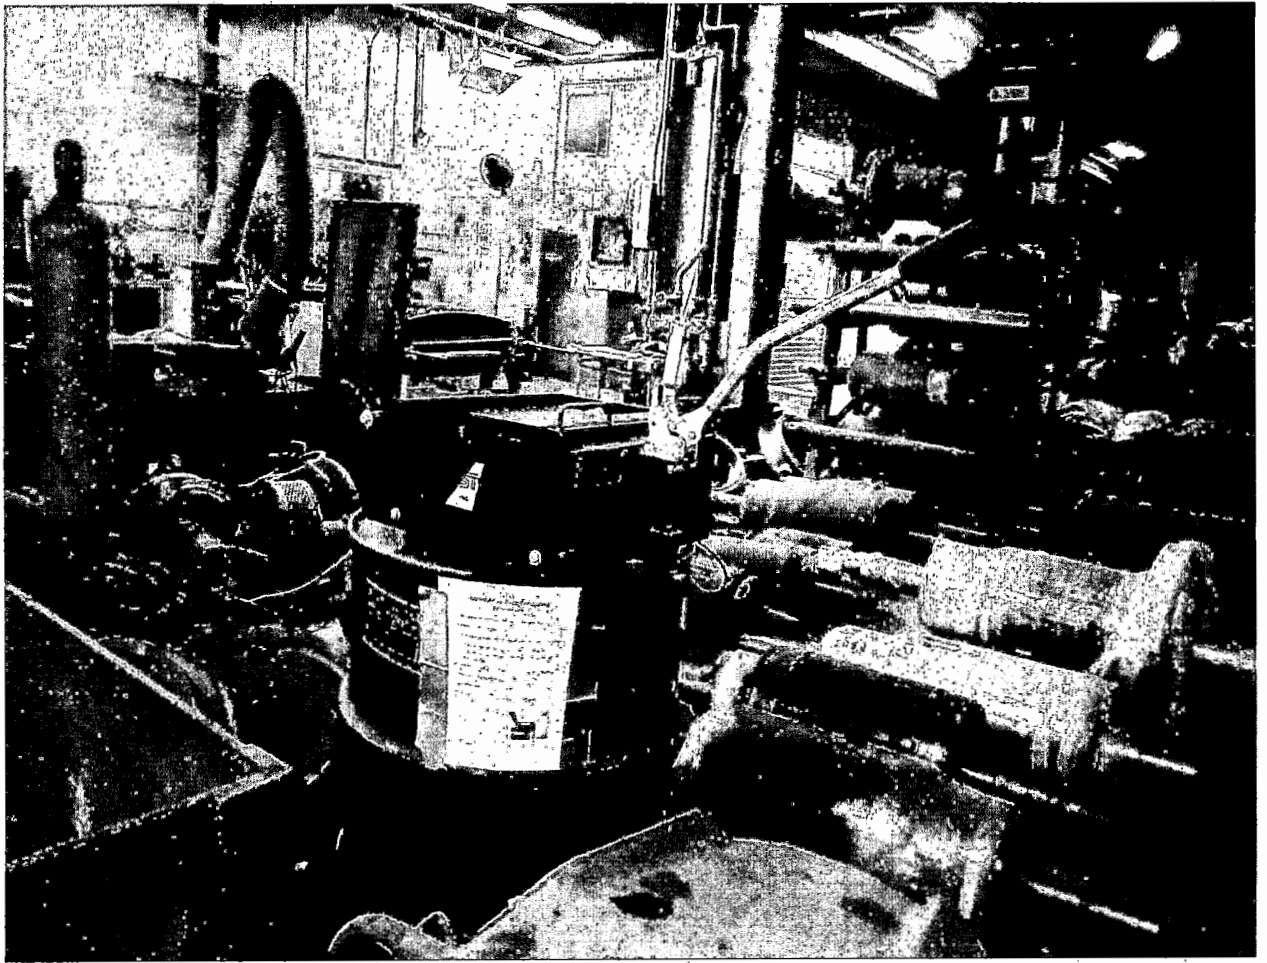
There are aerosol can "deflators" (Photos #7 & #8) puncturing devices located in 8 to 10 locations throughout the facility. The drums of waste are managed as satellite accumulation areas.

Photo #7 – Aerosol can puncturing device and satellite accumulation drum.

Photo #8 – Same drum as Photo #7 but showing hazardous waste label and operating instructions.

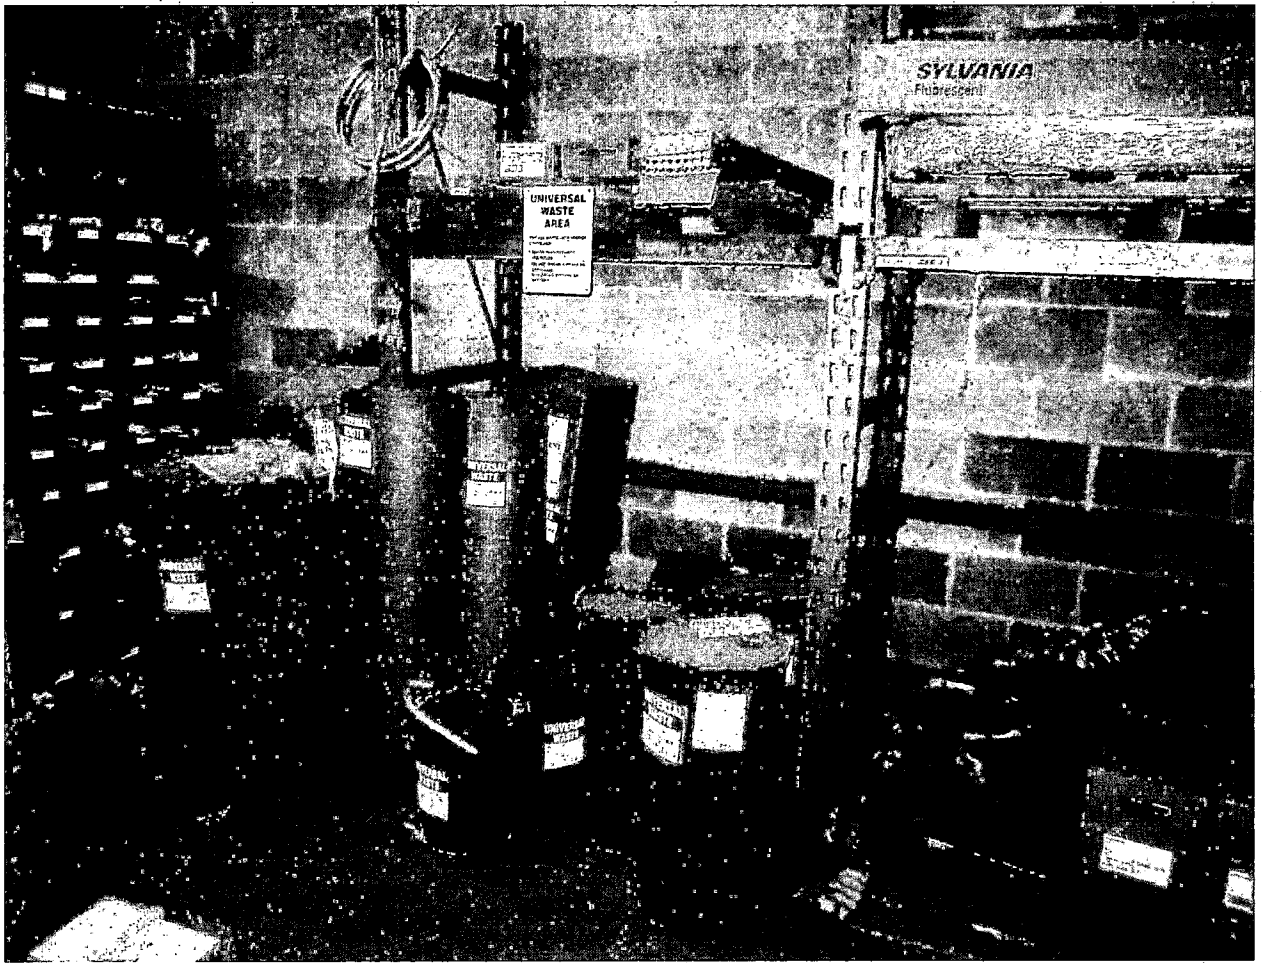
Universal wastes are stored in the storeroom area (Photo #9). A recent pickup by Safety Kleen left only new bulbs on the racks. All the other containers were empty except for a small black bucket (Photos #10 & #11) and a taller yellow container (Photo #12). All of the containers were labeled Universal Waste but the black bucket was not dated. The yellow container, dated 10/26/14, contained all alkaline batteries which are not hazardous.

Photo #9 – Universal waste storage area. All containers on the floor were empty except for two containers of batteries. The boxes on the shelving unit were verified to be new bulbs.

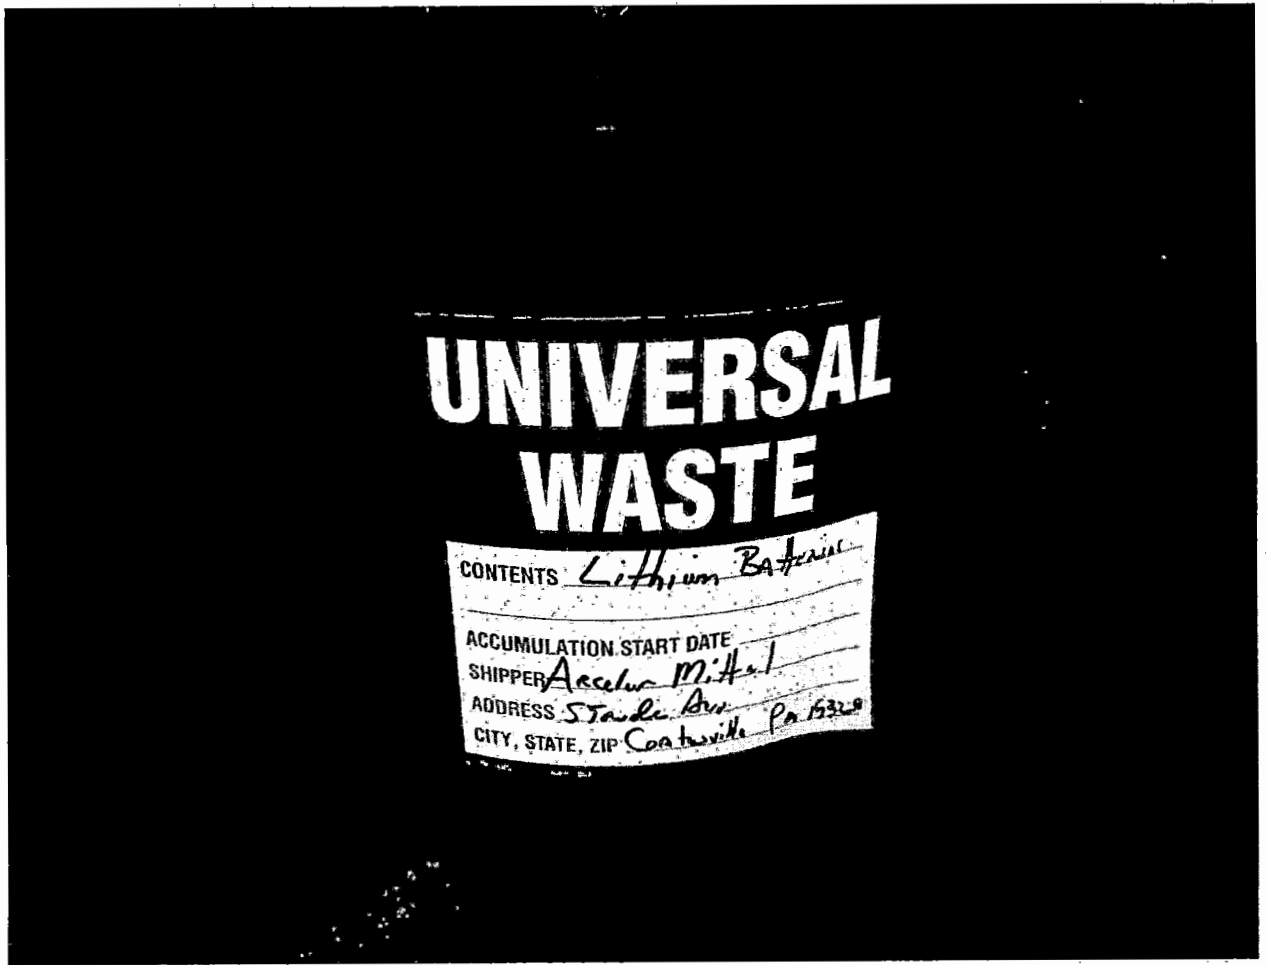
1. Universal Waste batteries were observed (Photos #10 & #11) to be stored in an undated container in violation of 25 PA 266b [40 CFR 273.15(c)].

Photo #10 – Undated container of lithium batteries.

Photo #11 – Lithium batteries in undated container shown in Photo #10.

The e-mail you sent on 4/8/15 documents that the violation was corrected on the same day after the inspector had left the facility; therefore, no response to this NOV is necessary.

After the inspectors departed, Mr. Ajalli e-mailed a copy of the Bill of Lading for the last shipment of Universal Waste lamps and a photograph of the date on the container of batteries which was observed to be missing earlier (Attachment F).

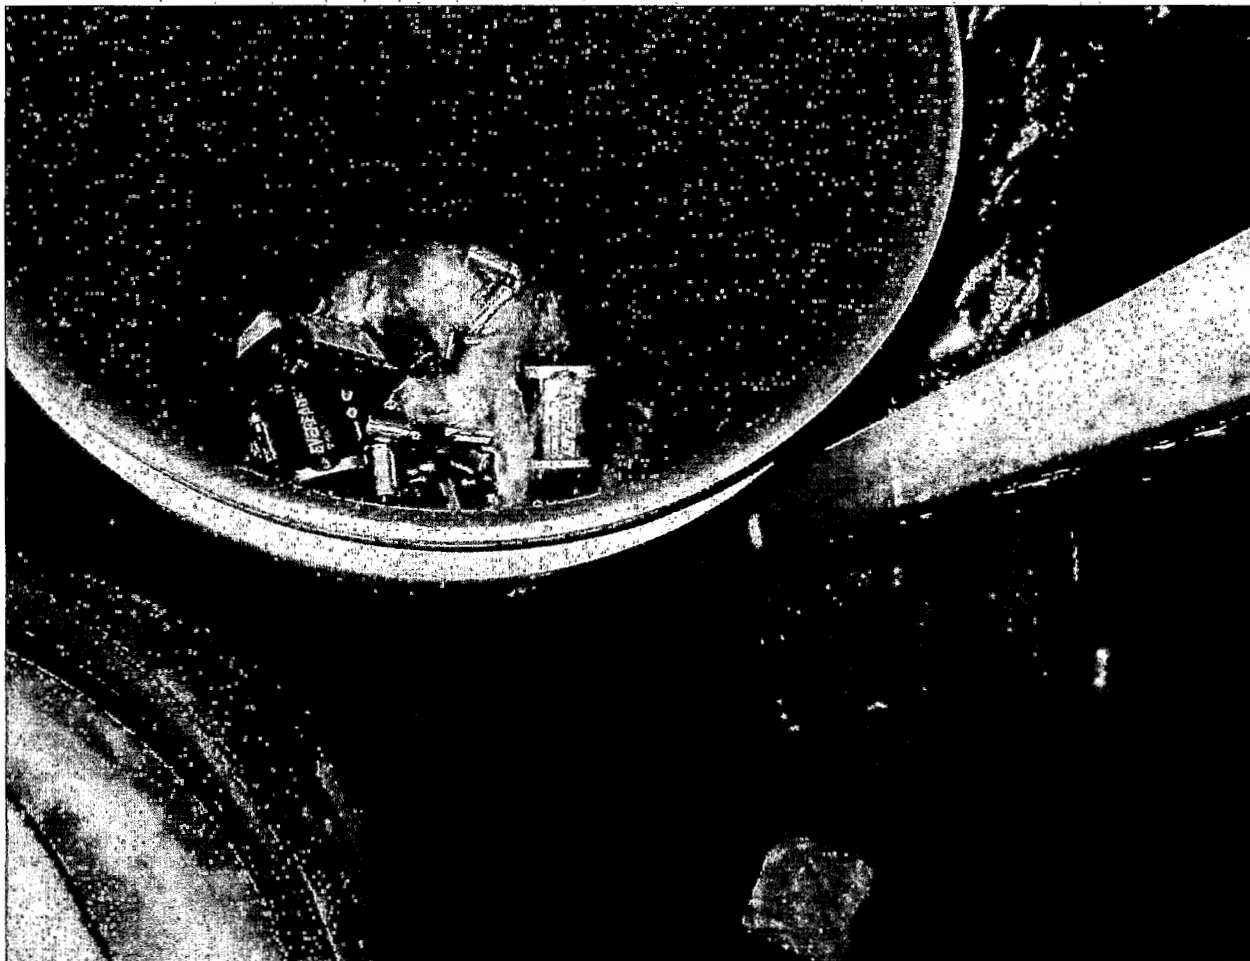
Photo #12 – Contents of container of batteries which was labeled and dated 10/26/14.
